## FAR-REACHING EFFECTS OF INADEQUATE PULSATION CONTROL

*Case study examines slamming check valve far from a reciprocating double diaphragm pump*

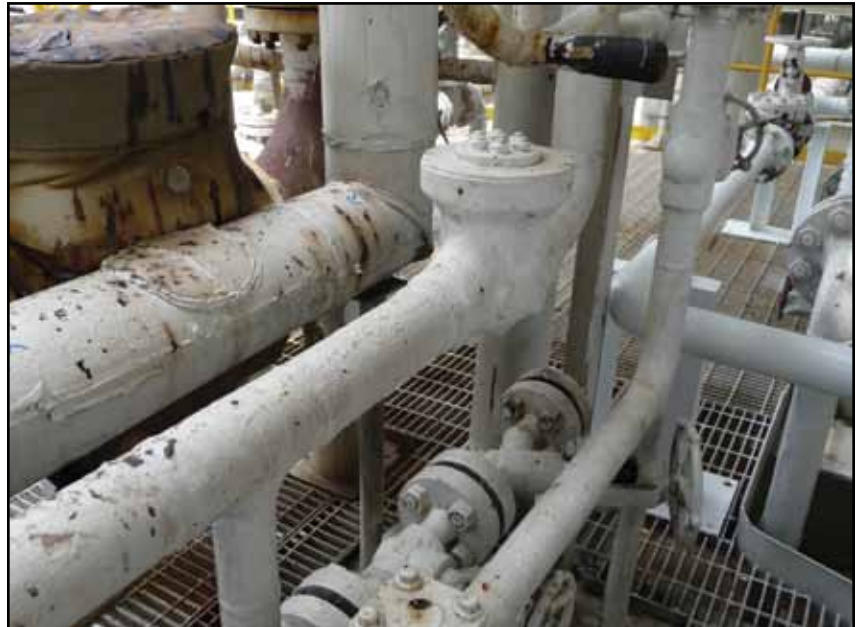
Operators of a large refinery first noticed a slamming noise and some broken U-bolt clamps on a pipe five stories up on a pipe rack. The noise came from a banging check valve on a 3 in. (76.2 mm) line among several larger pipes and valves.

**Slamming check valve (center of the photo) due to pulsation.**

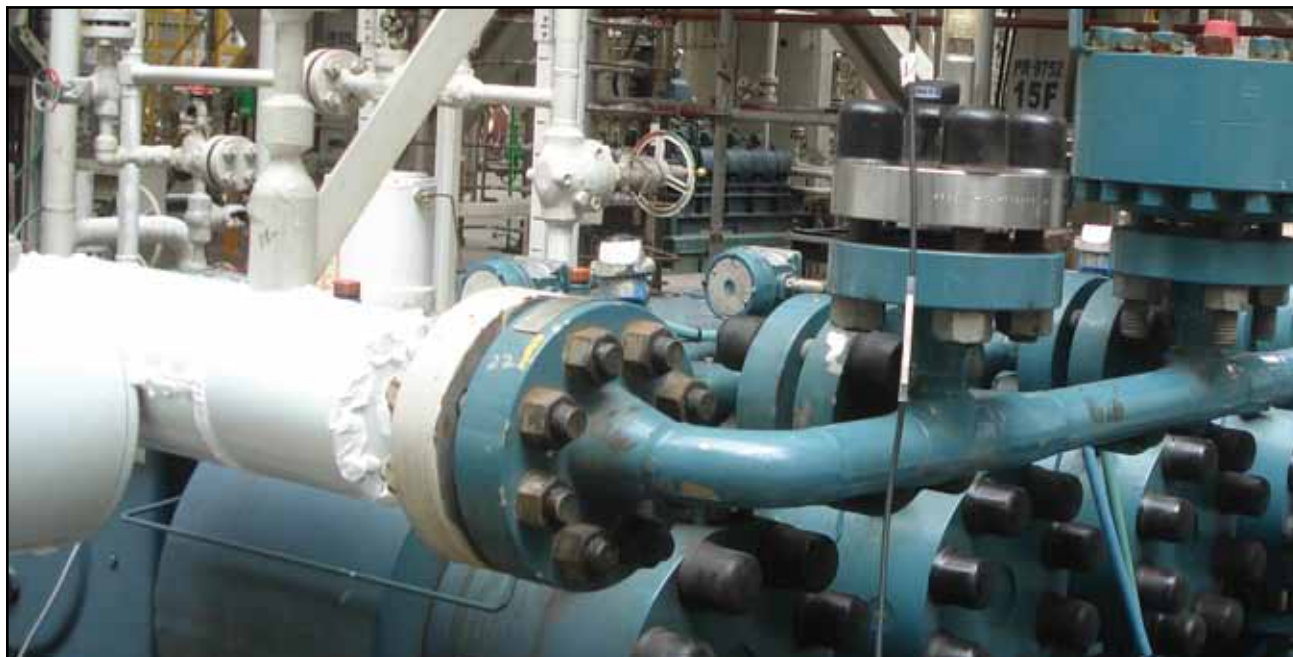
Shown here is the Quadruplex double-diaphragm pump.

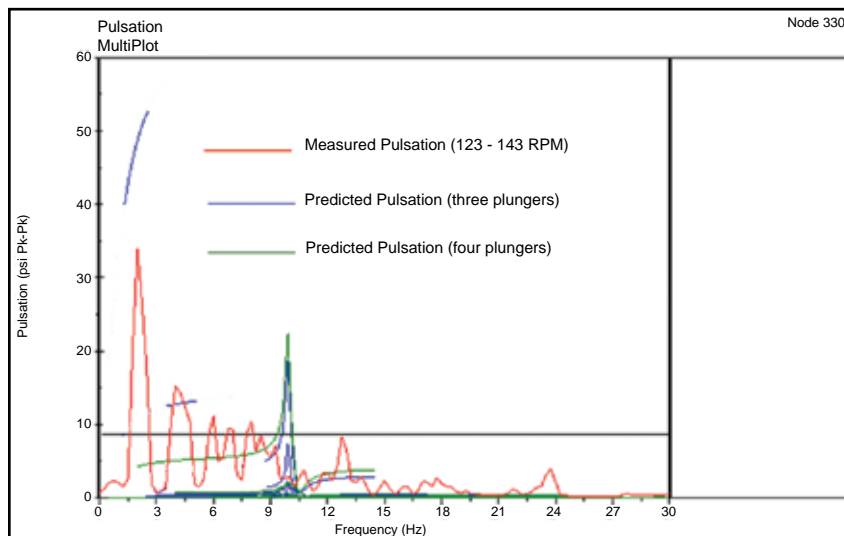
A flow comparison of measured and predicted flows revealed a 25% shortfall and that one plunger was not flowing product at the time of field testing. A simulation was then completed using the pulsation model of a pump with only three plungers active. To help validate the model, the three-plunger model results were compared to the field pulsation data collected near the slamming check valve.

As can be seen in the pulsation plot illustration, the shape and characteristics of the four-plunger prediction did not match the field data at all, while there was a much more qualitative and quantitative similarity between the three plunger model and the measured field data.

This graph shows predicted pulsation compared with measured field pulsation at the check valve.

Single dampeners are often ineffective at many speeds of a variable speed pump (see April 2012 *CompressorTech*<sup>Two</sup>, p. 58). In order to provide control of pulsation across the entire speed range of the system, a second dampener was required for both systems.

The customer chose to implement a maintenance-free, liquid-filled damp-

ener option so the pump system would maintain some pulsation control, even if the existing gas charged dampener lost its charge or failed.
